Manhole Inspection Summary

Manhole # S27G__029MH

Location Address: **923 W Baltimore** Cross Street: **N Poppleton St**

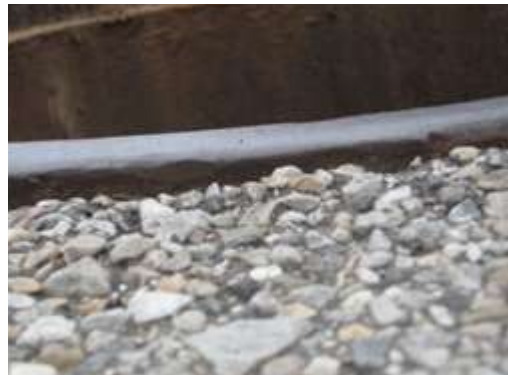
Frame above grade

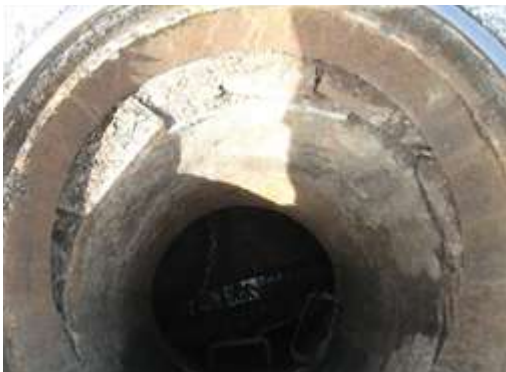
Defect 5

Condition: ☒ Sound ☐ Cracked ☐ Root Intrusion ☒ **Loose Brick** ☐ Deteriorated

Infiltration: ☐ None ☒ **Joint** ☐ Cracks ☒ **Mortar** ☐ Roots ☒ **Wall**

chimney cond loose bricks, missing mortar

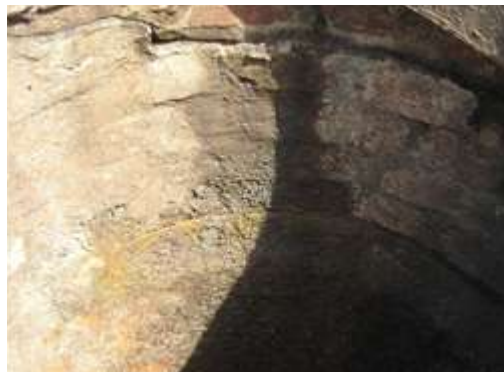
Defect 4

chimney flow wall

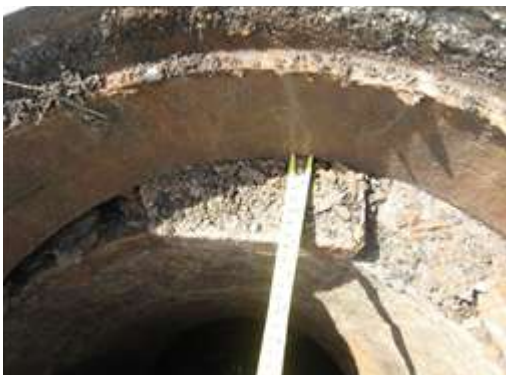
Frame offset

Frame Offset: **2.** (in.) Condition: ☐ Sound ☐ Cracked ☒ **Leaks**
75

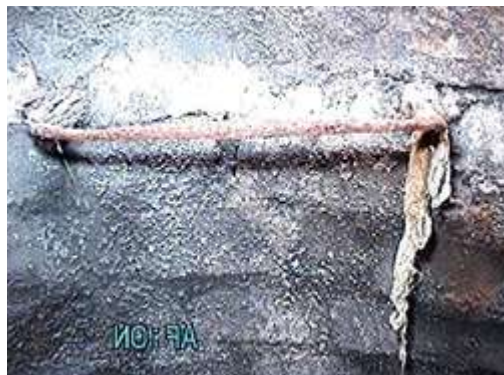
Defect 3

Surcharge ☒ **Evidence Of Surcharge** Depth: **4** (ft.) ☐ Active Surcharge Present

signs of surcharge

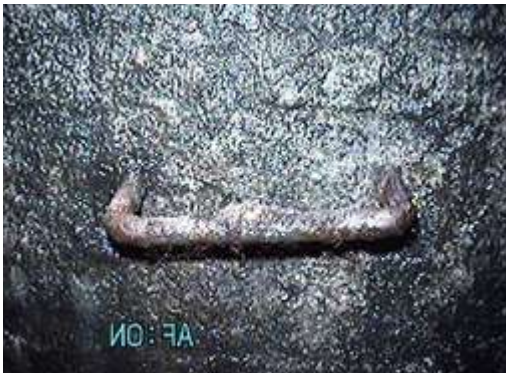
Defect 2

Infiltration: ☐ None ☐ Joint ☐ Cracks ☐ Mortar ☐ Roots ☒ **Wall**

Steps Count: **6** Missing: **0** ☒ **Corroded**

corroded steps, Barrel flow wall

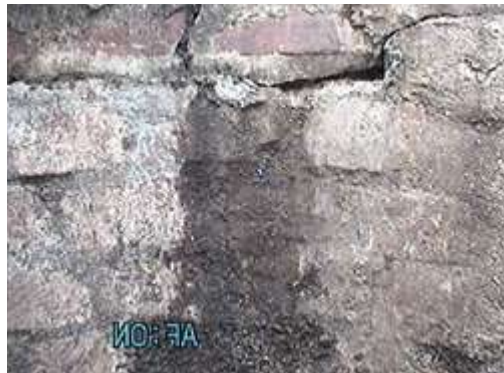
Defect 1

chimney cond cracked, chimney joint

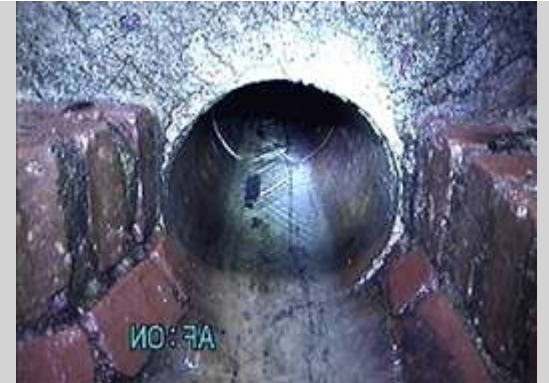
12 O'Clock Outflow

Pipe Height: **8.4** (in.) Rod and Bar (Angled)
Pipe Material: **Clay** ☐ Pipe Lined
Invert Depth: **10.98** (ft.) Flow Characteristics: **Fast**
Deposits: ☒ None ☐ Mud ☐ Sludge ☐ Debris ☐ Grease
Silt Depth: **0** (in.) Deposits Extent:
Infiltration: **Evidence** Pipe Seal Cond: **Unknown**

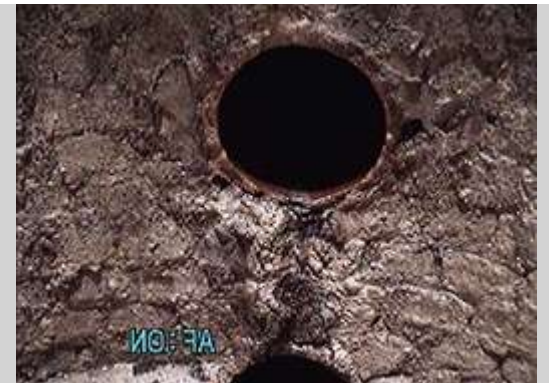
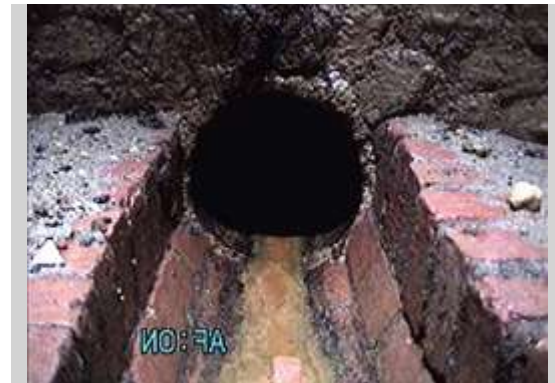
2 O'Clock Inflow

Pipe Height: **8.4** (in.) Rod and Bar (Angled)
Pipe Material: **Clay** ☐ Pipe Lined
Invert Depth: **9.44** (ft.) Flow Characteristics: **Slow**
Deposits: ☒ None ☐ Mud ☐ Sludge ☐ Debris ☐ Grease
Silt Depth: **0** (in.) Deposits Extent:
Infiltration: **Evidence** Pipe Seal Cond: **Unknown**

Drop: **Inside** Rod and Bar
Angled: **Yes** Reading: **9.57** (ft.)
Inv Depth: **10.57** (ft.)
Drop Condition: **Open**

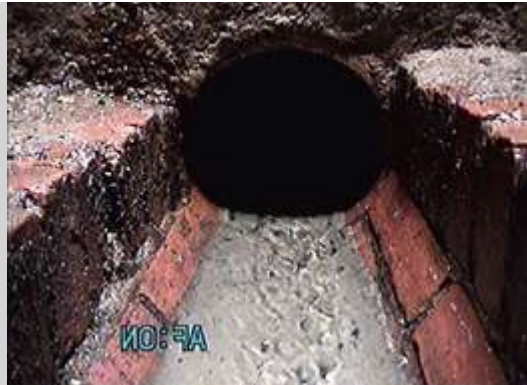
6 O'Clock Inflow

Infiltration: **Evidence** Pipe Seal Cond: **Unknown**
